**Professional Engineer's Statement
Everett Smelter Cleanup, 2000-2001**

Washington Department of Ecology Everett Smelter Site 2000 - 2001 Cleanup

Details of Cleanup Activities

Address: 116 Skyline Drive
 Everett, WA 98201

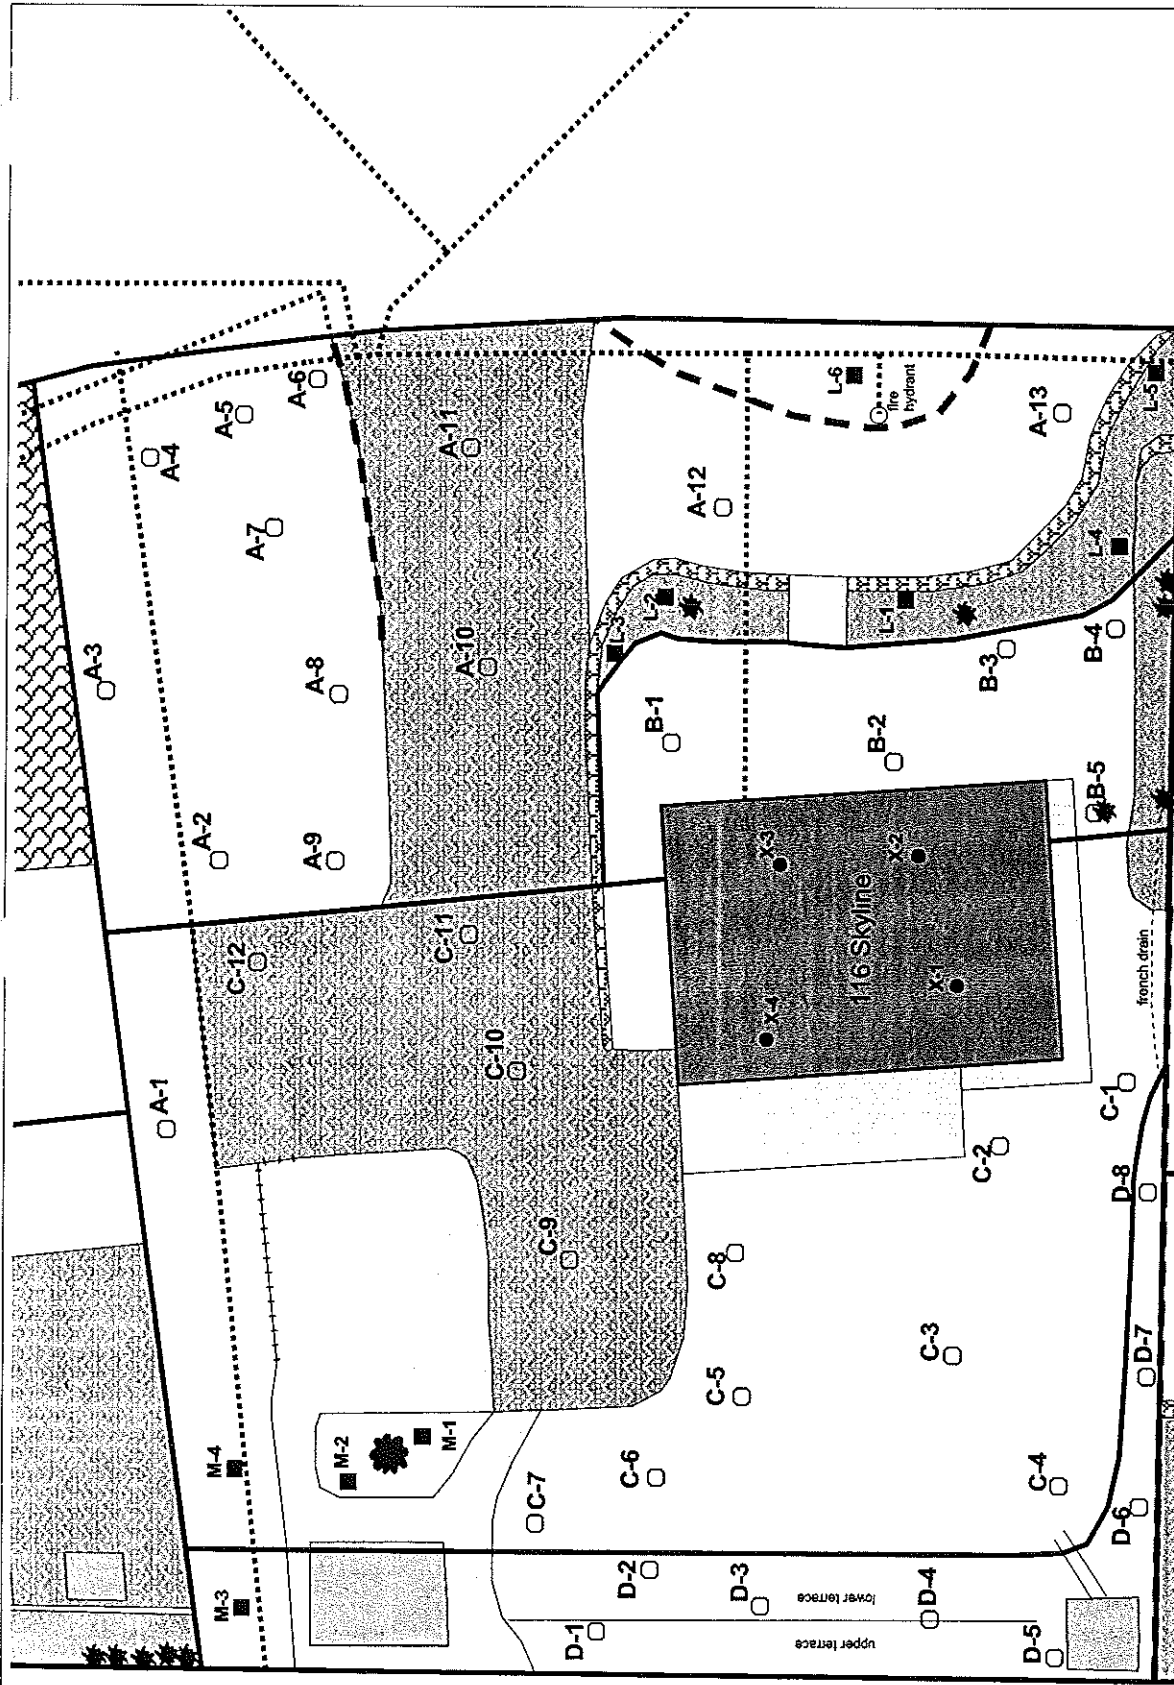
116 Skyline (Home 038)

This property was divided by Ecology into four Decision Units, A, B, C and D, as shown on the attached map, for purposes of pre-cleanup sampling and decision-making regarding the depth to which excavation was required. The following is a summary of the work done in the remediation of the property within each of the decision units.
